**BIOLOGICAL RESOURCES
TECHNICAL REPORT FOR THE
SOUTH BAY POWER PLANT
ABOVE-GROUND DEMOLITION
PROJECT IN SUPPORT OF A
COASTAL DEVELOPMENT PERMIT**

Dynegy South Bay, LLC
990 Bay Blvd.
Chula Vista, CA 91911

October 24, 2011

Bill Magdych Associates Environmental Consulting

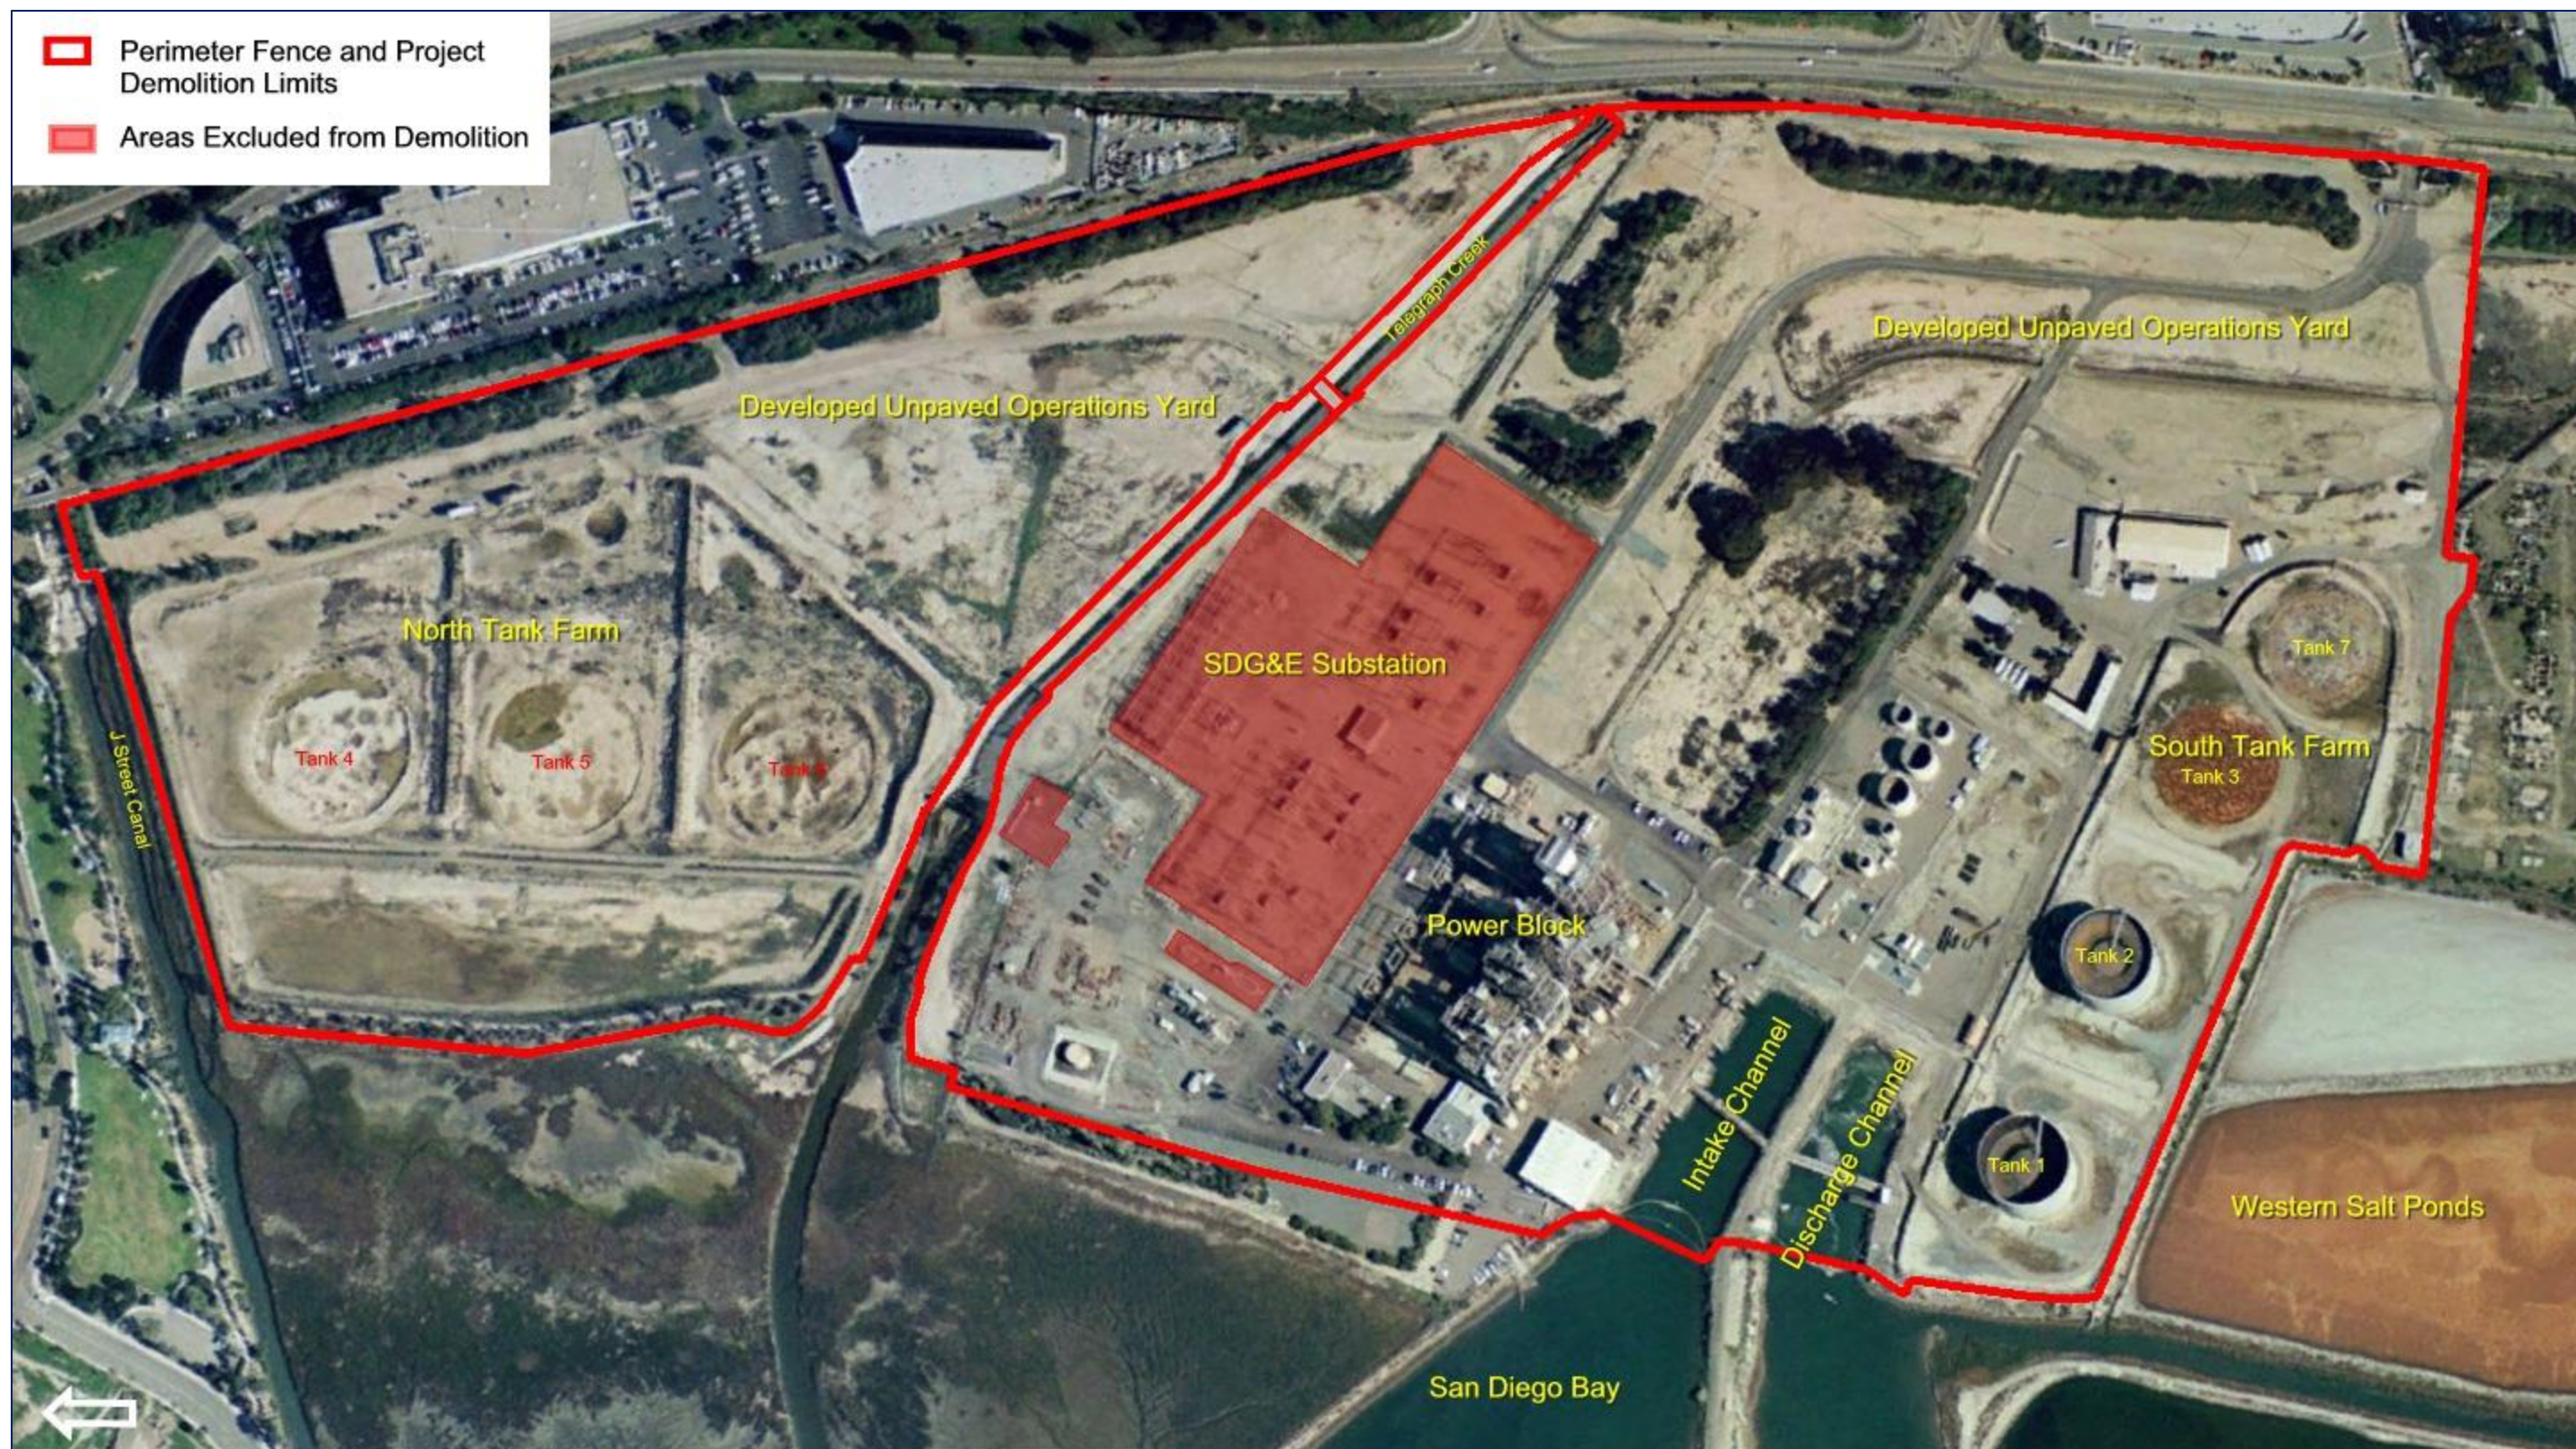
Figure 3. Aerial photograph of the South Bay Power Plant Site and limits of demolition

The plant site is fully developed and includes paved developed areas with the power block and various buildings, the developed north and south tank farms, and the remaining developed, unpaved yard on site (Figure 3). The north and south tank farms included engineered spill containment berms and substrates, tank foundations, fuel oil storage tanks, and associated distribution pipes, structures, and buildings. The north and south tank farms were maintained as barren ground during power plant operation, although regular maintenance has not occurred recently in the north tank farm since the tanks were removed from this area approximately 10 years ago. Landscape plantings, including lawn and shrub areas were developed around the main administration building and other areas. Screening berms that are either planted with ornamental species (all of Australian origin) or maintained without vegetation occur around the bayward perimeter of most of the site. Additional screen berms occur in developed, unpaved yard, and these berms have ornamental landscape plantings of Australian origin. The greater developed yard is maintained as barren ground. There is also a stormwater conveyance system constructed in uplands that includes lined, gravel, and earthen ditches, culverts, pipes, and discharge points to San Diego Bay, Telegraph Creek, and the J Street Canal.

The SBPP site meets the California Coastal Act definition of a “development” at Chapter 2, Section 30106 of the act as a fully developed site. The existing development is inclusive of all project features described in Sections 1 and 2 of this report. No vegetation grows in the paved portion of the site or areas developed with buildings and other material constructs. These areas do not provide regular habitat for wildlife, although birds occasionally perch, rest, or loaf on the SBPP structures and in the paved area, and other wildlife may enter also enter these areas for short periods of time. Figure 3 shows an aerial photograph of the apparent paved/built areas at the SBPP site.

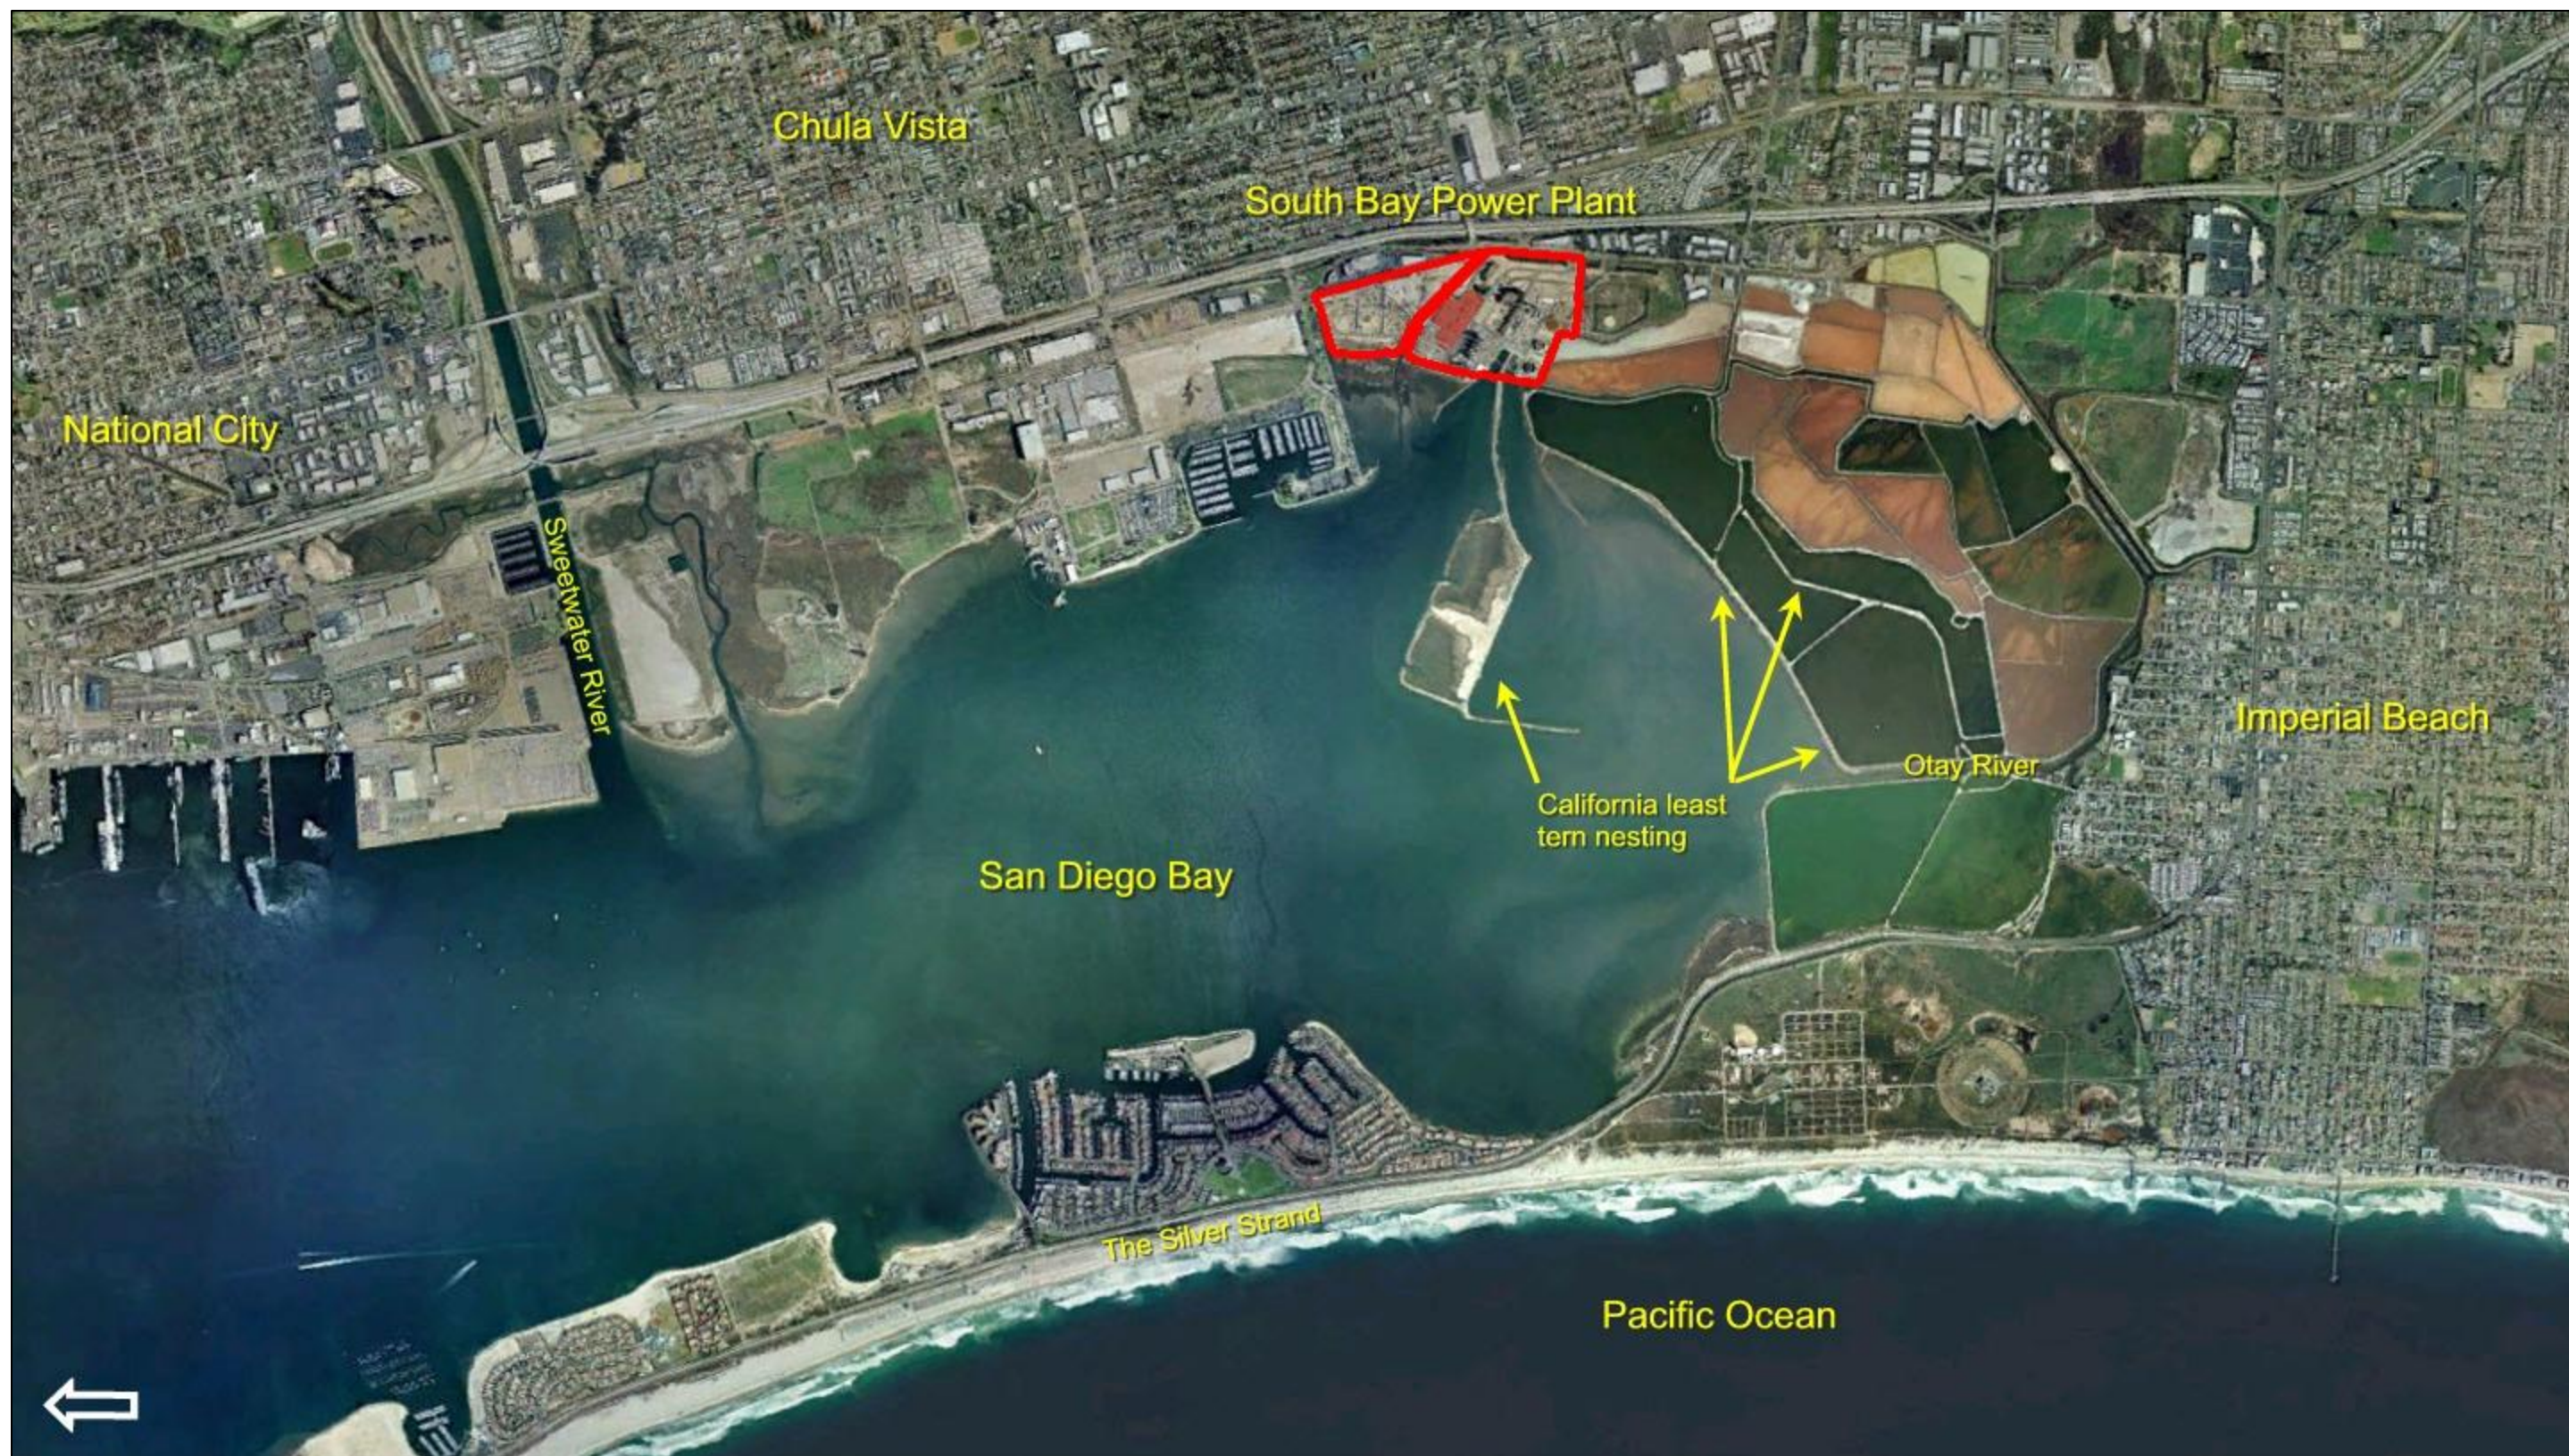
Figure 7. Aerial photograph of the local region near the South Bay Power Plant

Figure 6 shows the biological resources mapped on the project site. Figure 7 shows an aerial photograph of the regional area, showing developed and undeveloped lands outside of the SBPP site.

Much of the area surrounding the SBPP site is under urban and industrial development (Figure 7). This development includes the cities of Chula Vista and National City to the south/southeast, east, and north. San Diego Bay runs along the west side of the SBPP site and the intertidal lands west of the site support salt marsh and mudflat habitats used by all species common to these habitats in the region. Salt ponds for Western Salt occur southwest of the site. The ponds themselves near the plant side are areas where salt is harvested and do not provide substantial habitat for marine related species. The berms of the salt ponds and areas on the peninsula/island separating the intake and outfall flows in San Diego Bay west of the site provide nesting habitat for California least tern (*Sterna antillarum browni*). The nesting areas are generally greater than 0.75 miles from the power block on the SBPP site. The nesting island is owned and managed by the San Diego Unified Port District. The California least tern forage in the waters of San Diego Bay, including the waters west of the SBPP. California least tern are Federal and State Endangered. They do not nest on the SBPP site.

The intertidal waters of San Diego Bay, the J Street Canal, and Telegraph Creek (Figures 6 and 7) meet the definition of Coastal Commission wetlands; however, these wetlands are outside of the impact area for the SBPP demolition project. San Diego Bay supports salt marsh habitat that grades from pickleweed (*Salicornia virginica*) and cordgrass (*Spartina foliosa*) dominated wetlands to high marsh wetlands dominated by alkali heath (*Frankenia salina*). However, these areas also occur beyond the perimeter fence and boundary of the SBPP and will not be affected by this demolition project.

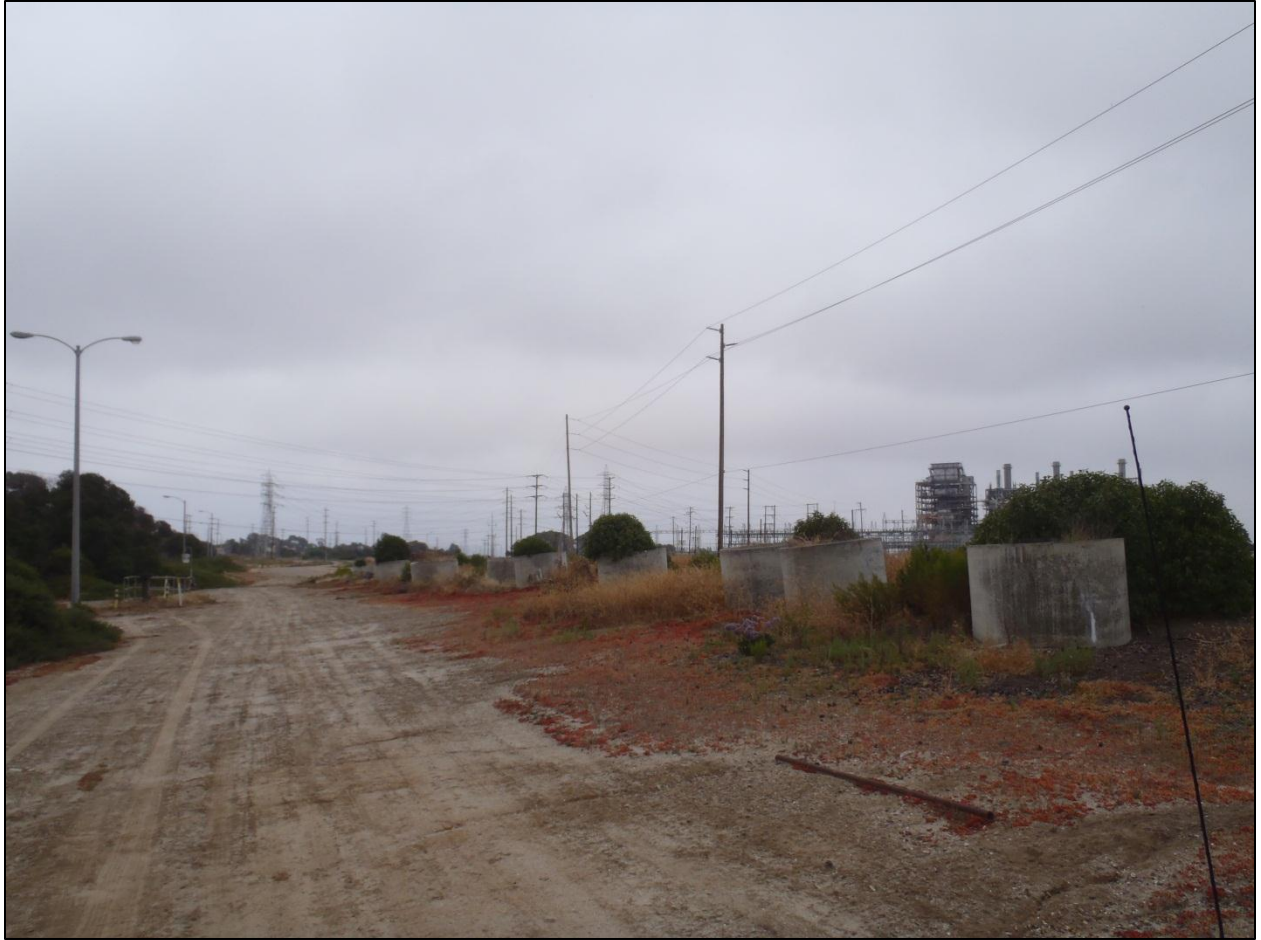
Figure 8. Large concrete potted shrubs and trees on north portion of site

Removal and/or salvage of ornamental landscape plantings may occur within the above-ground demolition area adjacent to structures and buildings that may be demolished (Figure 6). Additionally, 13 large potted trees and shrubs may be removed,

along with 21 other large concrete “pots” that had prior plantings that are no longer present or growing. These ornamental plantings provide minimal habitat for wildlife and serve as attractions to potential avian predators that may prey upon California least terns. Therefore, removal of these ornamental plantings will not result in significant adverse impacts on biological resources on site and is expected to benefit California least tern by reducing risks from raptor predation of California least terns in the local vicinity.
